# Belzona 2211 Seals 550 Support Pads on a Carbon Steel Pipeline to Prevent Crevice Corrosion

ID: 9283

Industry: Chemical & Petrochemical  
Application: VPF-Valves, Pipes and Fittings  
Substrate: Carbon steel  
Products: Belzona 2211 (MP Hi-Build Elastomer), Belzona 2921 (Elastomer GP Conditioner)

Customer Location: India  
Application Date: November 2022

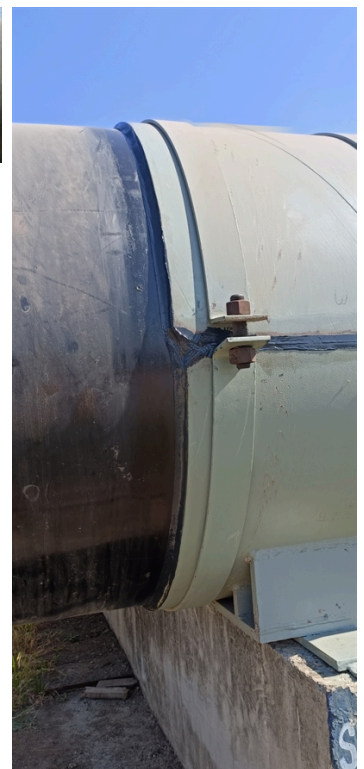
Water ingress had caused localised corrosion on the metal pads that support the joints of a 45 km-long, 60-inch-diameter carbon steel pipeline. The client was looking for a solution to fill these gaps and prevent any risks of water ingress for over 500 support pads.

Carbon steel pipeline in question

The application on one of the support pads in progress

A gap on the pipeline sealed with Belzona 2211 to prevent water ingress

Close-up photo of completed application

First, the paint on the edges of each metal pad was removed by machine buffing and hand tools. Surface preparation was then carried out with a wire brush and MBX Bristle Blaster.

After the surface preparation was completed, a thin coat of Belzona 2921 (Elastomer GP Conditioner) was applied onto each metal pad. Belzona 2211 (MP Hi-Build Elastomer) was then applied to fill the gaps between the metal pads and the pipeline. Belzona 2211 was pressed in as thoroughly as possible to eliminate the void between the pipeline and the support.

After a 24-hour cure time, the application was inspected to ensure there were no air bubbles and other defects.
