RESTORING AND COATING E5B HEAT EXCHANGER FACE

ID: 9288

Application: HEX-Heat Exchangers

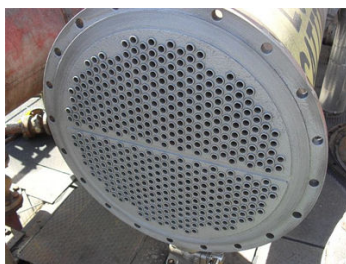
2.) After Blasting

The application area was marked out before the tube face was grit blasted to SA2.5, achieving a minimum 75-micron profile. After blasting, the tube face was rebuilt with Belzona 1111, followed by 2 coats of Belzona 1321, each coat was applied at 250-375 microns. After the Belzona had cured, a visual inspection was carried out and any areas requiring touch-ups were marked up, abraded, and then re-coated.
