RESTORING AND COATING E5B HEAT EXCHANGER FACE

ID: 9288

Application: *HEX-Heat Exchangers*

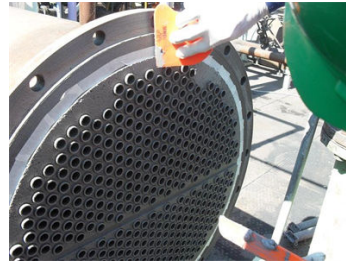
3.) Applying Belzona 1111 for the rebuild

The application area was marked out before the tube face was grit blasted to SA2.5, achieving a minimum 75-micron profile. After blasting, the tube face was rebuilt with Belzona 1111, followed by 2 coats of Belzona 1321, each coat was applied at 250-375 microns. After the Belzona had cured, a visual inspection was carried out and any areas requiring touch-ups were marked up, abraded, and then re-coated.

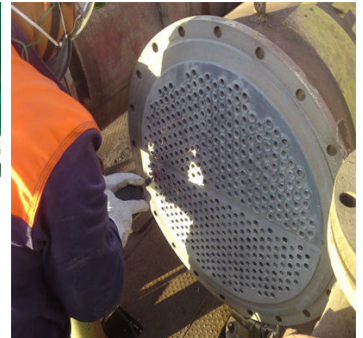
4.) Final application - removal of corks

Before the HEX was put back in service, the equipment passed a hydrostatic test carried out by the client under a pressure of 30 kg/cm².
