# BELZONA COATS STACK WHILST IN SERVICE

ID: 929

Industry: General Industry  
Application: CEP-Centrifugal Pumps  
Substrate: Steel  
Products: Belzona® 5851 (HA-Barrier)

Customer Location: North American Galvanizing  
Application Date: July, 2007

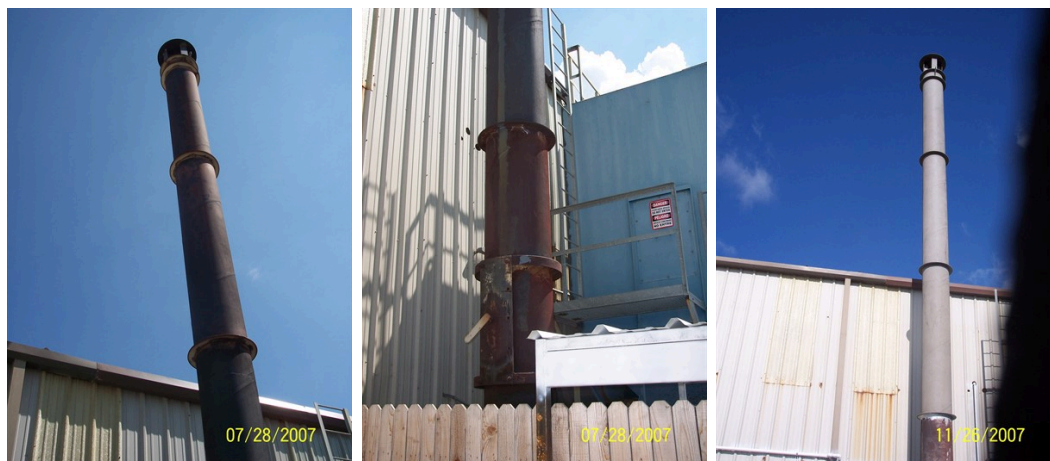
## Photograph Descriptions

External corrosion protection required but stack could not be taken out of service.

\* Original chimney , \* Test strip - top portion, bottom - burned portion , \* Final application - 4 months later ,

Vent stack for hot gases operating between 300 & 550°F (150 & 280°C) internal temperature.

Brush applied with a 4" bristle brush by hand.

Coating was less expensive than any other alternative considered by customer. It also allowed application without taking chimney out of service saving more time and money. Belzona® 5851 also required no surface preparation saving more time and money.
