CO2 Absorber Rubber Lining Replaced with Belzona Coating System

ID: 9290

Customer Location: RAS LAFFAN, QATAR

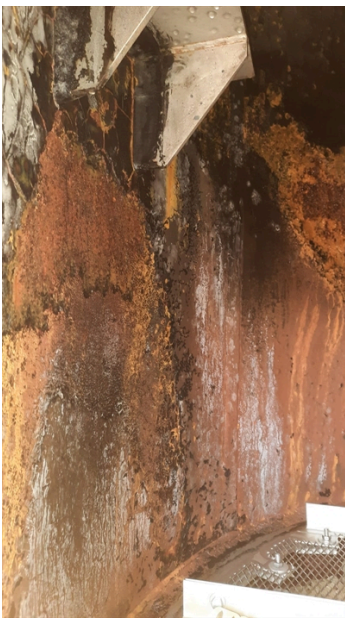
The rubber lining of the CO2 absorber was swelling, blistering and crackings throughout the tank interior. Corrosion damage to the base metal was so pronounced that it could be glimpsed through cracked/delaminated rubber lining.

Traces of severe corrosion from under the rubber lining

The damaged rubber lining was replaced with a Belzona epoxy coating system. The original system thickness requirement by the customer was a minimum of 2 mm, as the previous rubber lining was 3 mm thick. The proposal initially considered was a 2 mm thick build-up with Belzona 1111, but it was too costly and over budget to cover the entire interior surface, so Belzona 5811 was used for the build-up instead of Belzona 1111.

Three coats of Belzona 5811 (Immersion Grade) were applied as filler and to cover the wall loss. Belzona 1331 was applied as the final top coat.

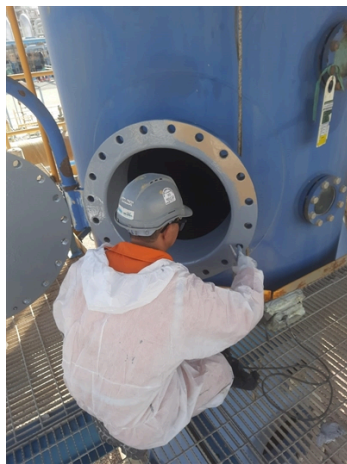
Coating application in progress to the manway and flange

Each coat was applied using an airless spray machine. The materials were applied in accordance with the relevant Instruction For Use and the guidance of approved method statement.

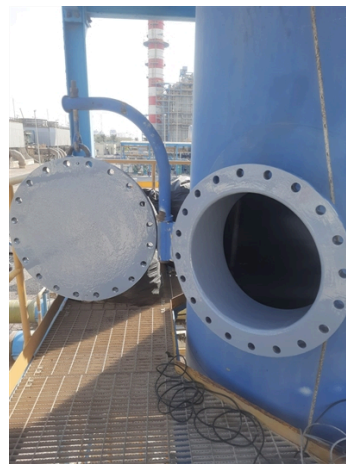
Manway and flange coated and protected

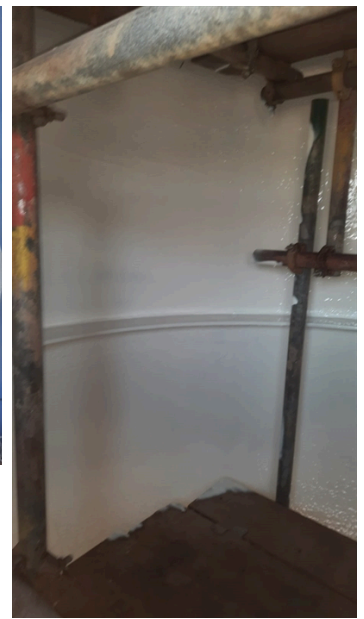
Protected tank interior after application

Almost all internal surfaces had pitting and Belzona 5811 was applied directly to the substrate to fill and seal the pitted, uneven surfaces without the use of smoothing paste grade material. Belzona 1331, applied as a topcoat on the premise of contact with the medium, offers excellent erosion/corrosion resistance and a long service life.
