CO2 Absorber Rubber Lining Replaced with Belzona Coating System

ID: 9290

Industry: Power
Application: TCC-Tanks and Chemical Containment Areas
Substrate: Carbon steel
Products: Belzona 1331, Belzona 5811 (Immersion Grade)

Customer Location: RAS LAFFAN, QATAR
Application Date: December 2023

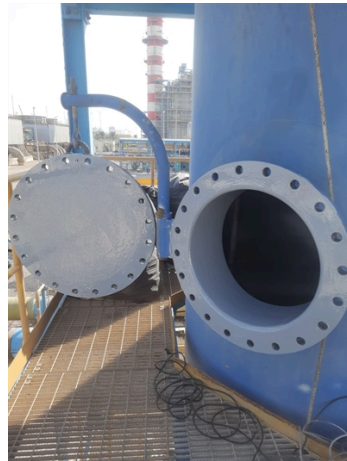
Manway and flange coated and protected
