Belzona 4111 Fills the Concrete Cracks in Warehouse Floor to Maintain Safety in Workplace

Industry:	Buildings & Structures	Customer Location:	Italy
Application:	FPA-Floor Problem Areas	Application Date:	
Substrate:	Concrete		
Products:	Belzona 4111 (Magma-Quartz),Belzona 4151 (Magma-Quartz Resin),Belzona 4911 (Magma TX Conditioner)

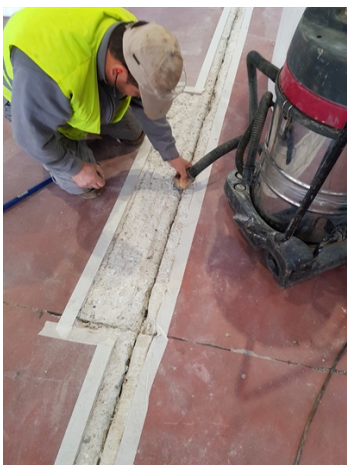
Cleaning after the preparation to remove dust and small debris

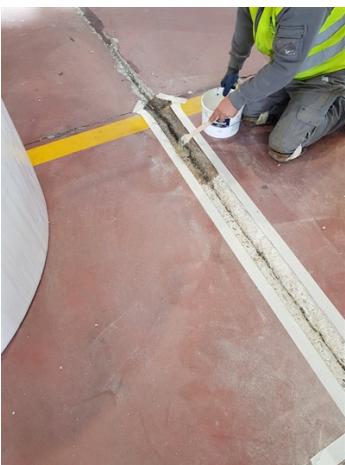
Belzona 4911 Conditioner applied to the exposed concrete substrate in the repaired area

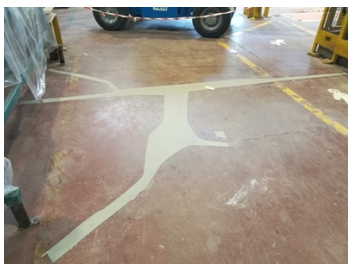
Complete repair on a warehouse floor
