Belzona 4111 Fills the Concrete Cracks in Warehouse Floor to Maintain Safety in Workplace

ID: 9291

Industry: *Buildings & Structures* Customer Location: *Italy*
Application: *FPA-Floor Problem Areas* Application Date:
Substrate: *Concrete*
Products: *Belzona 4111 (Magma-Quartz), Belzona 4151 (Magma-Quartz Resin), Belzona 4911 (Magma TX Conditioner)*

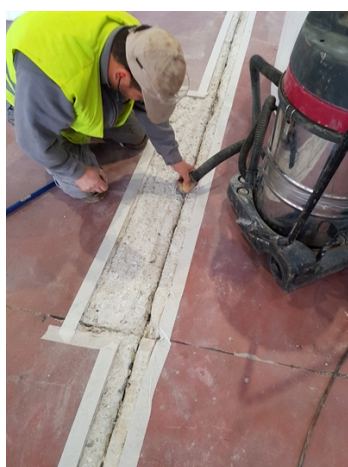
Cleaning after the preparation to remove dust and small debris

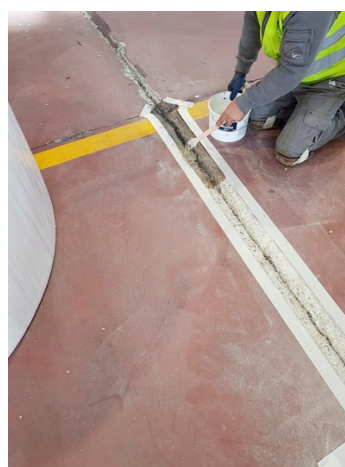
Belzona 4911 Conditioner applied to the exposed concrete substrate in the repaired area

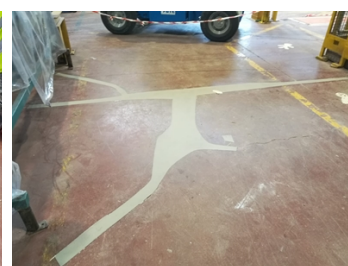
Complete repair on a warehouse floor
