Belzona Repairs Ballast Tank Perforations at Port Service Facility

ID: 9292

Customer Location: France
Application Date: August 2023

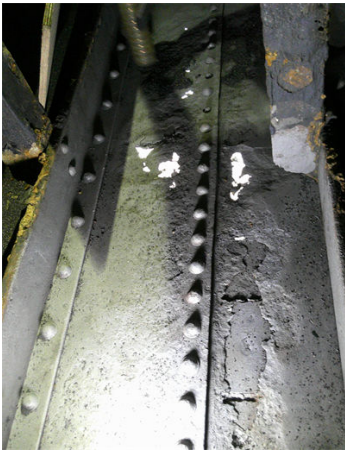
Extensive damage revealed at the tank bottom after blasting

The ballast tanks at this port service facility were suffering from corrosion due to exposure to seawater. Previously, metal pads had been welded to repair perforations in the tank. However, this triggered bimetallic corrosion, apart from the original problem of saltwater corrosion. As a result, the corrosion continued and extended around the weld bead and under the welded pads, resulting in through-wall defects.

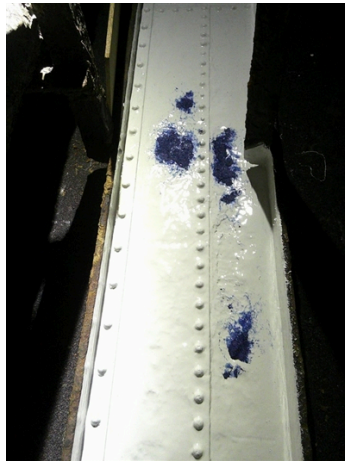
First coated throughout with Belzona 5831LT and pit filled with Belzona 1818

After surface preparation by blasting, Belzona 5811 and 5831LT were applied to the prepared surfaces; Belzona 5811 was applied to the dry areas and Belzona 5831LT to the damp areas. Belzona 1818 was then applied to fill voids and low spots over the applied coating. As a final finishing touch to the repair, a resin rich mix of Belzona 4151 and silica aggregate was poured over the repaired areas to reinforce and level out the bottom.

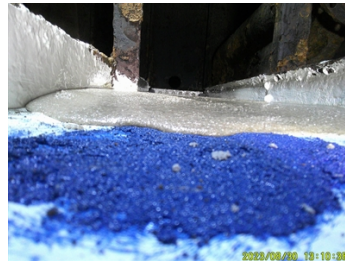
Belzona 4151-silica mixture was poured over Belzona 5831LT and 1818

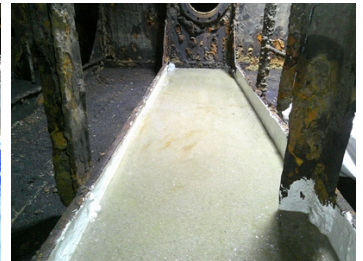
Complete application
