Belzona Repairs Ballast Tank Perforations at Port Service Facility

ID: 9292

Industry:	Marine	Customer Location:	France
Application:	TCC-Tanks and Chemical Containment Areas	Application Date:	August 2023
Substrate:	Other		
Products:	Belzona 1818, Belzona 4111 (Magma-Quartz), Belzona 4151 (Magma-Quartz Resin), Belzona 5811 (Immersion Grade), Belzona 5831LT

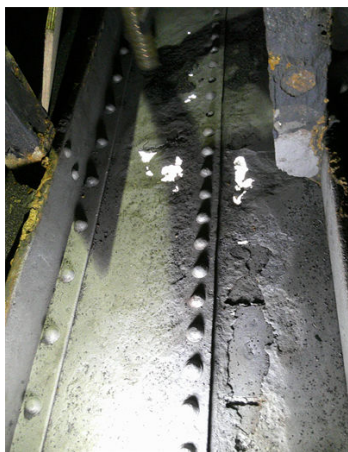
Extensive damage revealed at the tank bottom after blasting

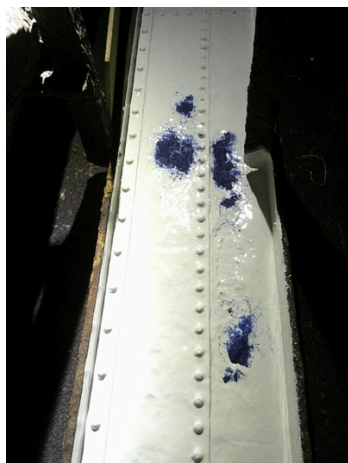
First coated throughout with Belzona 5831LT and pit filled with Belzona 1818

After surface preparation by blasting, Belzona 5811 and 5831LT were applied to the prepared surfaces; Belzona 5811 was applied to the dry areas and Belzona 5831LT to the damp areas. Belzona 1818 was then applied to fill voids and low spots over the applied coating. As a final finishing touch to the repair, a resin rich mix of Belzona 4151 and silica aggregate was poured over the repaired areas to reinforce and level out the bottom.

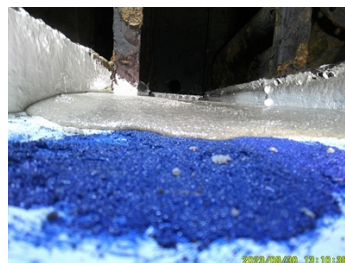
Belzona 4151-silica mixture was poured over Belzona 5831LT and 1818

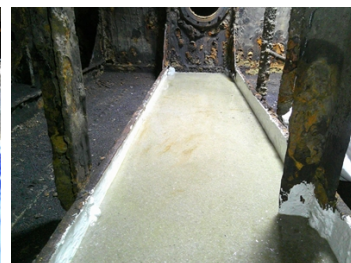
Complete application
