# Quick turnaround for Corroded Tank using Belzona Solutions

ID: 9293

Application: TCC-Tanks and Chemical Containment Areas

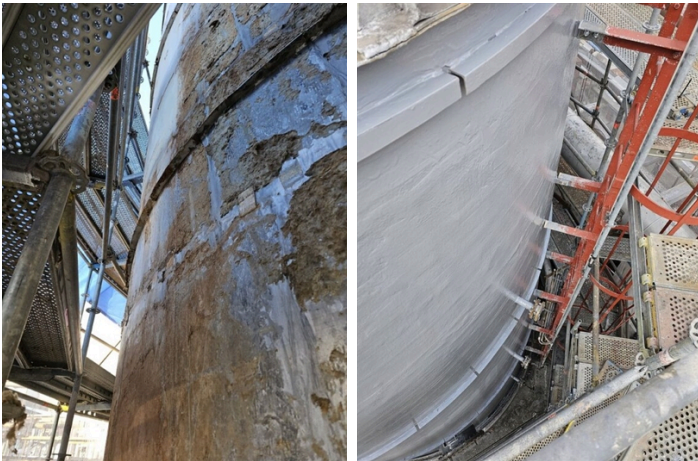
The Customer was experiencing weakening of their aluminium tank walls caused by corrosion for operational demineralised water.

Tank walls damaged caused by corrosion      Finished application

After the tank was blasted, we proceeded to replenish the pitting damages on the surface of the tank and then bandage the entire area with Belzona 1111 (Super Metal). Once the material had hardened, the surface was then prepared and Belzona 5811 (Immersion Grade) then applied in two layers. All the work was carried out on scaffolding with seven members of the application team as well as one inspector on site the entire application.
