# JET FUEL Tank's Pitting Corrosion

ID: 9294

Application: TCC-Tanks and Chemical Containment Areas

Substrate: Carbon steel

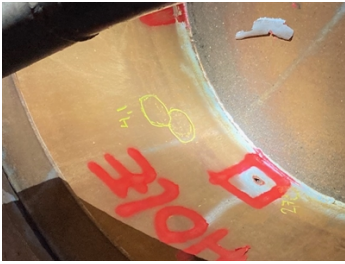
The Jet fuel tank had 14 points with pitting . The refinery wanted to fill up the tank with Jet fuel ASAP .

Big pitting with hole

We used Belzona 9611 for the big holes and then Belzona 1161 to cover the pitting .

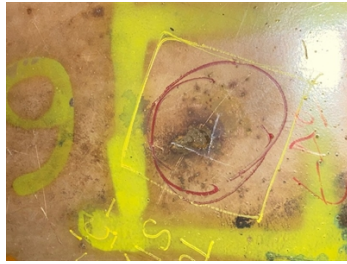
pitting

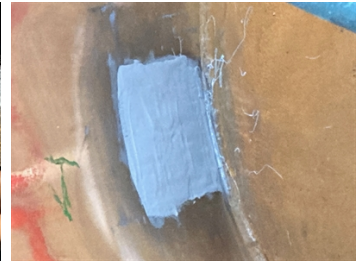
Hole after the application
