JET FUEL Tank's Pitting Corrosion

ID: 9294

Application: TCC-Tanks and Chemical Containment Areas

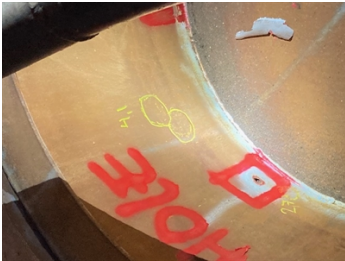
The Jet fuel tank had 14 points with pitting . The refinery wanted to fill up the tank with Jet fuel ASAP .

Big pitting with hole

We used Belzona 9611 for the big holes and then Belzona 1161 to cover the pitting .

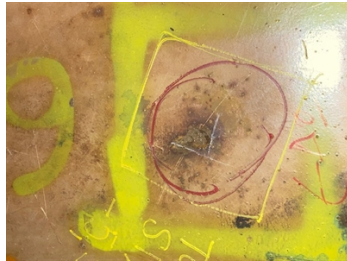
pitting

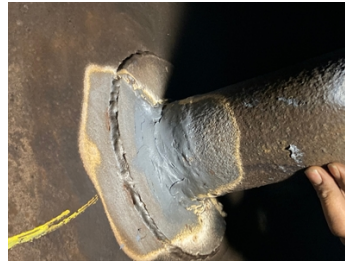
After the application of Belzona 1161

At the end we use Belzona 5811 for long term chemical resistance .

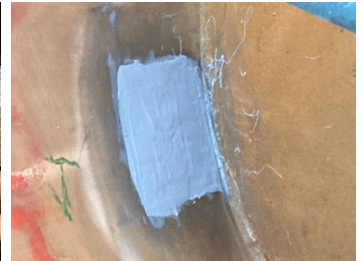
Hole after the application
