# Belzona Protects Ship Exhaust

**Industry:** Marine  
**Application:** VPF-Valves, Pipes and Fittings  
**Substrate:** Stainless-steel  
**Products:** Belzona 1391T, Belzona 9111 (Cleaner Degreaser)

**Customer Location:** Turkey  
**Application Date:** 2020

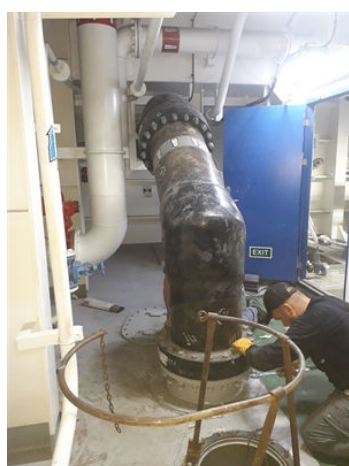
The steel pipe affected by scrubber exhausted emissions

Belzona 1391T, a high-temperature corrosion-resistant coating, was chosen to protect the affected steel pipes during a scrubber retrofit installation.

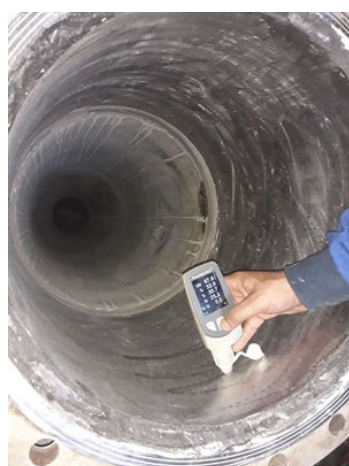
Surface Preparation

Before the project started, the surface climate conditions, salt content, and profile depth were closely monitored to ensure optimal results prior to the application. The sub-contractors and applicators underwent training, and the application began with cleaning the area using Belzona 9111 (Cleaner Degreaser). Following surface preparation an application of two coats of Belzona 1391T was followed by a careful post-curing process according to the provided instructions.

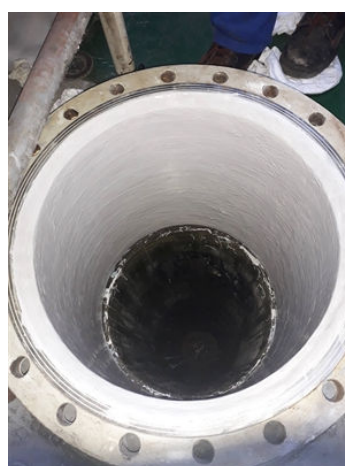
Finished application after two coats of Belzona 1391T

The application was completed over the course of one day, with an allowance of additional working hours for the post curing process. Heaters and dehumidifiers were used inside a tented area in order to ensure a controlled environment was achieved.

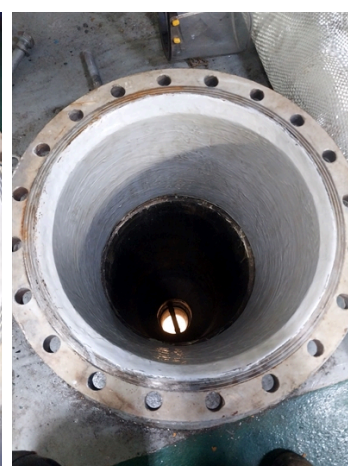
Application after being inspected two years later.

Since the process was done in 2020, the Distributor has revisited the ship and found that all of the coated scrubber passage pipes were found in perfect condition. The customer was happy and satisfied with the Belzona solution chosen.
