Extending life of Cement ball mill using Belzona products

ID: 9299

Industry: *Buildings & Structures*
Application: *SHM-Solids Handling Machinery*

Substrate: *Carbon steel*
Products: *Belzona 1111 (Super Metal)*

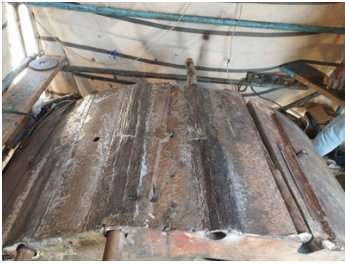
A cement ball mill was subjected to abrasions caused by the entrapment of cement particles under the mill tiles.

Damaged ball mill surface

Using conventional welding will consume a lot of time and will need machining: a slow process that stops production for a long time.

The Belzona solution is much easier, faster and needs no machining as we use the tile itself as a mould to restore the worn surfaces

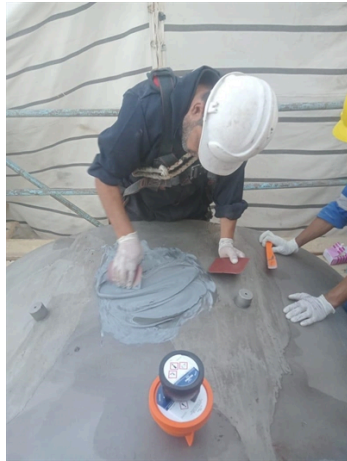
Applying Belzona 1111

- The Tiles are removed from the surface of the ball mill
- The surface below is roughened to ensure maximum adhesion and then cleaned with a non-residual cleaner.
- The tile is then brushed with Belzona 9411 release agent
- Belzona 1111 is applied to the surface below the tile and the tile is aligned and left to cure accordingly

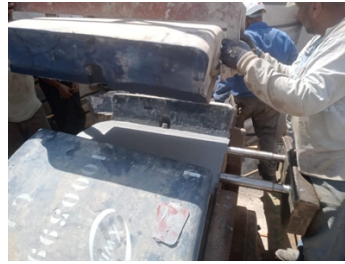
Aligning the tiles to be used as a mould

There is no need for machining as we use the tile itself as a mould to restore the worn surface.

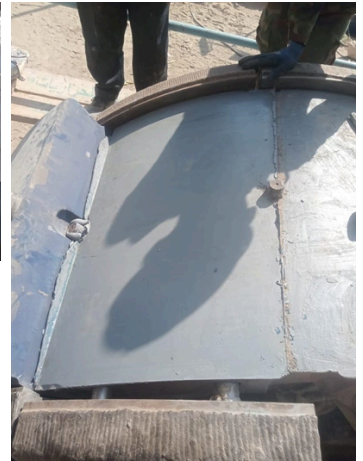
Application Complete
