Extending life of Cement ball mill using Belzona products

ID: 9299

Industry: Cement
Application: SHM-Solids Handling Machinery

Customer Location: Egypt
Application Date: August 2012

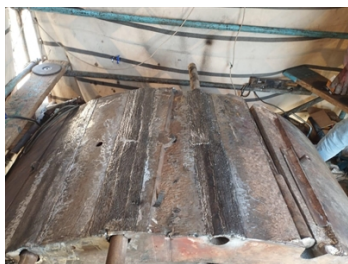
A cement ball mill was subjected to abrasions caused by the entrapment of cement particles under the mill tiles.

Damaged ball mill surface

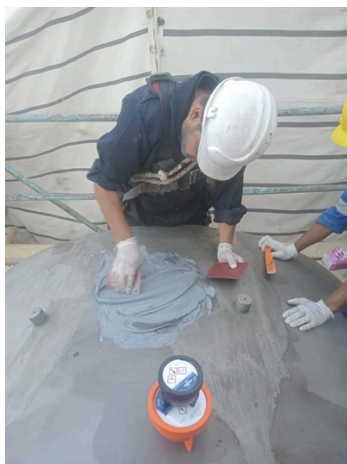
Applying Belzona 1111

- The Tiles are removed from the surface of the ball mill
- The surface below is roughened to ensure maximum adhesion and then cleaned with a non-residual cleaner.
- The tile is then brushed with Belzona 9411 release agent
- Belzona 1111 is applied to the surface below the tile and the tile is aligned and left to cure accordingly

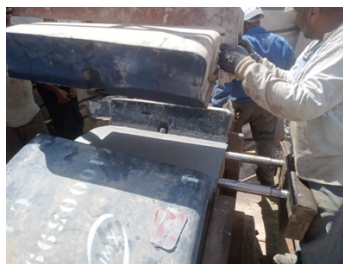
Aligning the tiles to be used as a mould

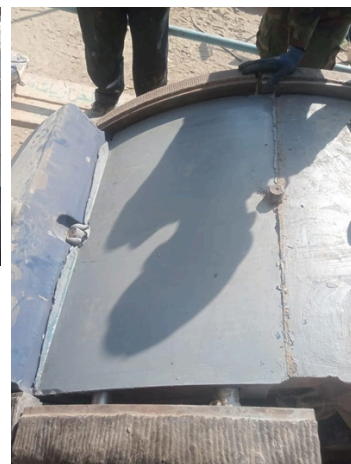
Application Complete
