REPAIR AND PROTECTION OF OIL/WATER SEPARATOR WITH BELZONA

ID: 93

Internal surfaces of an Oil/Water separation unit on an offshore production platform

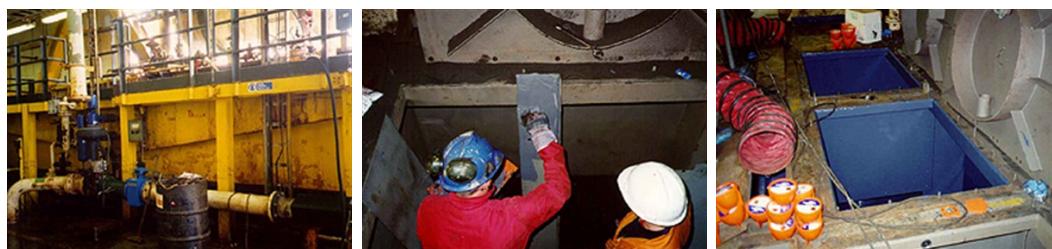
The original glass flake system failed in the severe erosion-corrosion conditions leading to holing of the unit

- * General view of the unit ,
- * Bonding doubler plates to holed areas ,
- * Belzona® 1391 providing complete protection to the separator internal surfaces ,

Application was carried out in accordance with Belzona® system leaflets TCC-1, TCC-2 & TCC-5. Doubler plates were bonded over holed and deeply pitted areas before applying Belzona® 1391 to provide erosion-corrosion protection over the entire area.
