Belzona Repairs a Transformer

ID: 9301

Customer Location: Amsterdam
Application Date: January 2024

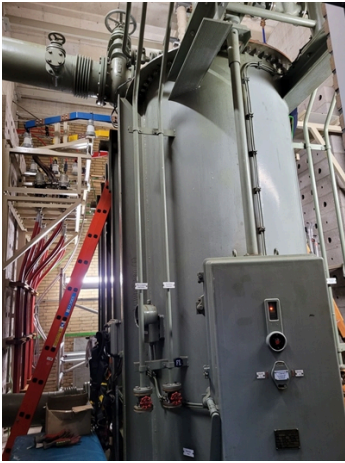
A large transformer in Amsterdam showed leaks on the flange face of the cover. Since the cover is full of connections and connections, it is not possible to detach the cover and thus replace the gasket.

Transformer to be repaired.

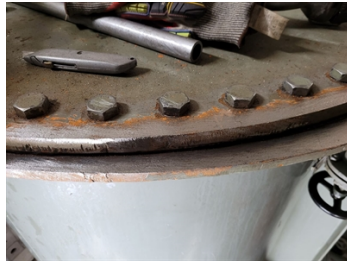
Area of the transformer leaking.

Before the Belzona products can be applied, it is important that the surface is cleaned and roughened. The edges are then sealed with the oil-tolerant paste for metal repair, the Belzona 1161. This is applied in combination with the Belzona 9341 reinforcement sheet.

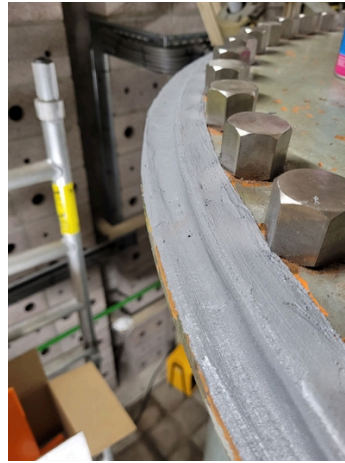
Belzona 1161 applied

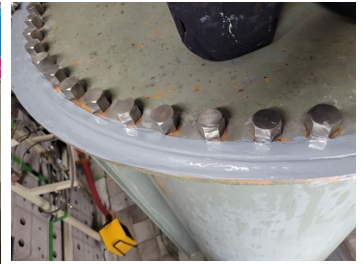
Application complete with a coating of Belzona 5831 over the Belzona 1161

The repair is finished with Belzona 5831 for extra protection. This epoxy coating for corrosion protection is again oil tolerant. The combination of products used repairs the transformer, in such a way that it will be leak-free for a long time. The application was carried out in accordance with Belzona system leaflet GSS-08.
