# Fast Curing Belzona Solutions for CUI on Tanks

**Industry:** Chemical & Petrochemical  
**Application:** TCC-Tanks and Chemical Containment Areas  
**Substrate:** Carbon steel  
**Products:** Belzona 5892

**Customer Location:** Belgium  
**Application Date:** February 2024

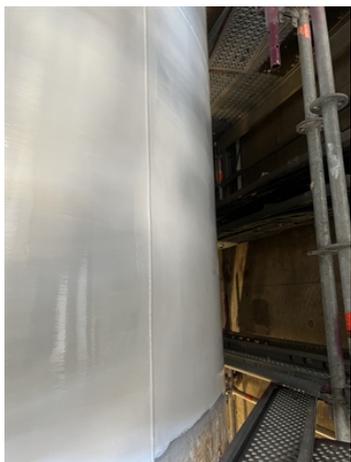
First coat of Belzona 5892 in white.

The substrate of the tank was blast cleaned while in service using the ATEX certified, Pinovo vacuum blasting equipment to 75 microns.

Two coats of Belzona 5892 were then applied on the same day, providing the customer with significant savings in time. The installation was then installed on top of the coating.

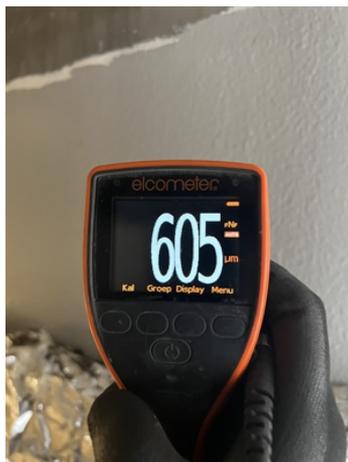
Completed application with coating thickness being checked.

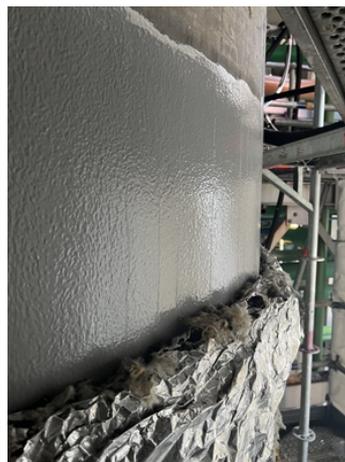
Completed coating with insulation reinstalled.
