# Fast Curing Belzona Solutions for CUI on Tanks

ID: 9303

**Industry:** Chemical & Petrochemical  
**Application:** TCC-Tanks and Chemical Containment Areas  
**Substrate:** Carbon steel  
**Products:** Belzona 5892

**Customer Location:** Belgium  
**Application Date:** February 2024

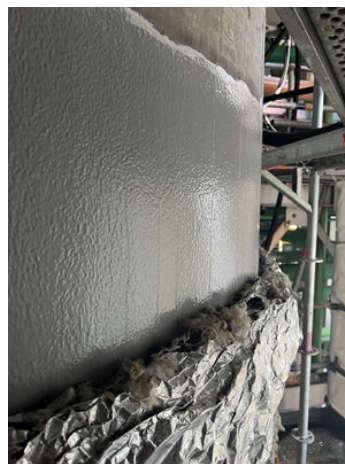
Completed coating with insulation reinstalled.

Two coats of Belzona 5892 were then applied on the same day, providing the customer with significant savings in time. The installation was then installed on top of the coating.
