# Belzona Elastomer Restores an Expansion Joint in a Public Swimming Pool

Application: FPA-Floor Problem Areas

Substrate: Concrete

Products: Belzona 2211 (MP Hi-Build Elastomer), Belzona 2911 (Elastomer QD Conditioner)

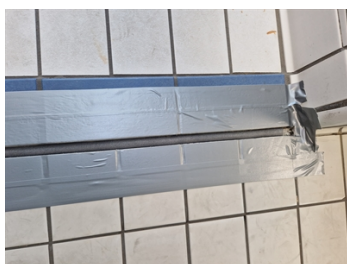
Measurement of the defective expansion joint in order to calculate the required quantity of product.

The old silicone expansion joint was removed and a grinder was used to prepare the surface for the application of Belzona. The area of defective joint was measured to calculate the product required to complete the application. Masking tape was utilised to properly mark and delineate the application area and to maintain a clean finish.

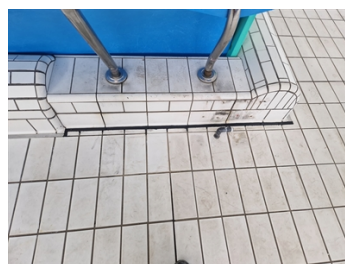
The application area was marked with tape to delimit the application area. A backer rod was inserted into the joint prior to the application of Belzona 2211.

A thin layer of Belzona 2911 (Elastomer QD Conditioner) was applied to the prepared surface and allowed to dry before a backer rod was inserted into the joint. Humidity level was also checked using a hygrometer to ensure suitable atmospheric conditions for the application.

Belzona 2211 (MP Hi-Build Elastomer) was then thoroughly mixed and applied to the joint to form a new expansion joint.
