Belzona Elastomer Restores an Expansion Joint in a Public Swimming Pool

Problem

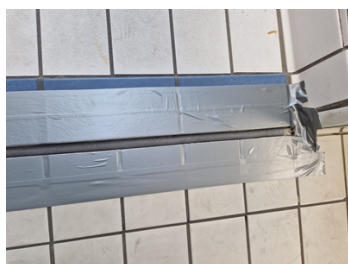
Measurement of the defective expansion joint in order to calculate the required quantity of product.

The old silicone expansion joint was removed and a grinder was used to prepare the surface for the application of Belzona. The area of defective joint was measured to calculate the product required to complete the application. Masking tape was utilised to properly mark and delineate the application area and to maintain a clean finish.
