# Belzona 1812 protects newly fabricated screw conveyor.

ID: 9314

Industry: *Mining & Quarrying*  
Application: *SHM-Solids Handling Machinery*

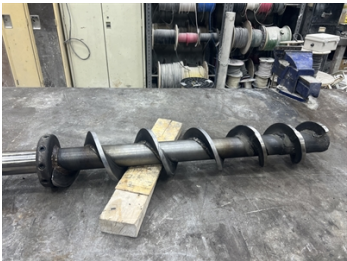
Screw conveyor before surface preparation.

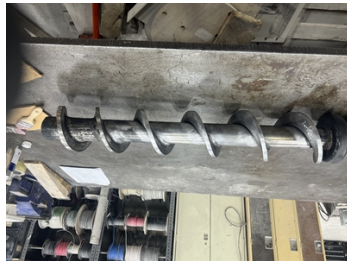
After surface preparation.

Surface preparation with MBX bristle blaster, grinder and solvent cleaning with Belzona 9111.

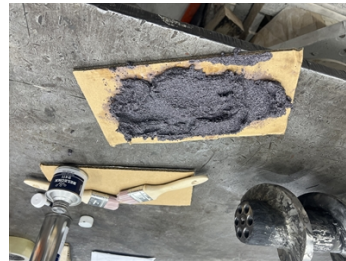
Mixed Belzona 1812.

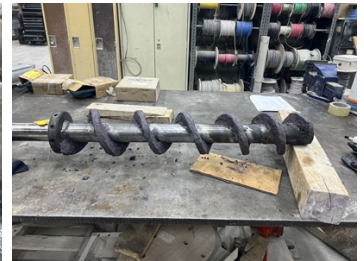
After application of Belzona 1812.
