Belzona 1812 protects newly fabricated screw conveyor.

ID: 9314

Application: SHM-Solids Handling Machinery

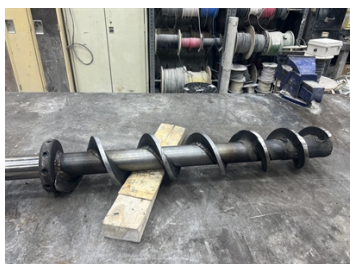
Screw conveyor before surface preparation.

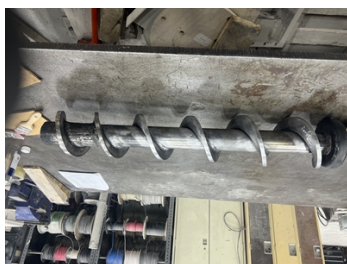
After surface preparation.

Surface preparation with MBX bristle blaster, grinder and solvent cleaning with Belzona 9111.

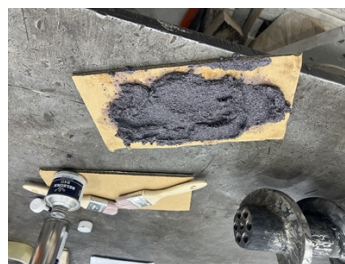
Mixed Belzona 1812.

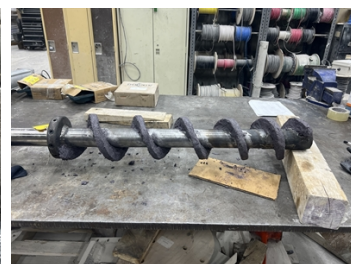
After application of Belzona 1812.
