Belzona 1812 protects newly fabricated screw conveyor.

ID: 9314

Application: SHM-Solids Handling Machinery

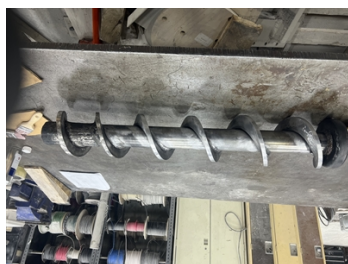
After surface preparation.

Surface preparation with MBX bristle blaster, grinder and solvent cleaning with Belzona 9111.

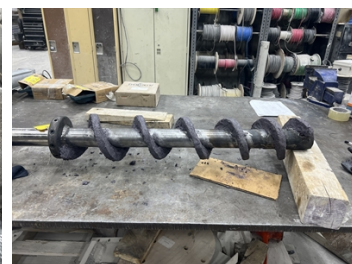
After application of Belzona 1812.
