# Bow Thruster Tunnel Repair

ID: 9315

Industry: *Marine*  
Application: *SOS-Ships and Offshore Structures*

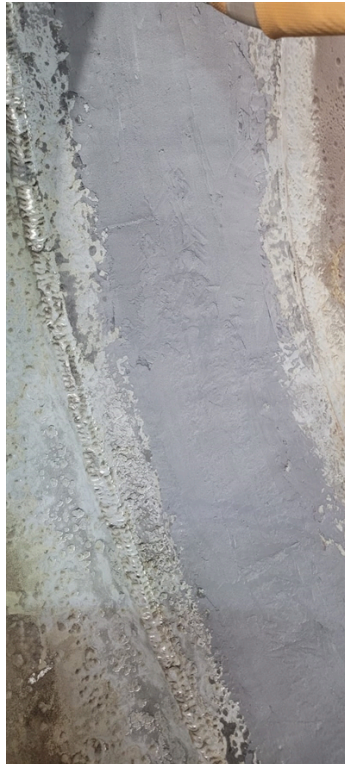
*Deep pitting on the bow thruster tunnel due to cavitation*

After surface preparation and rebuilding with Belzona 1311

Surface preparation was carried out using the MBX bristle blaster, degreased and allowed to dry. Pitting was filled with Belzona 1311 and two coats of Belzona 1321 was applied.

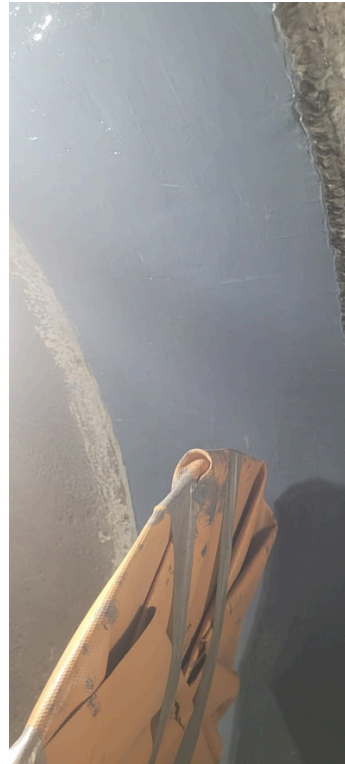
With first coat of Belzona 1321
