Bow Thruster Tunnel Repair

ID: 9315

Industry: *Marine*
Application: *SOS-Ships and Offshore Structures*

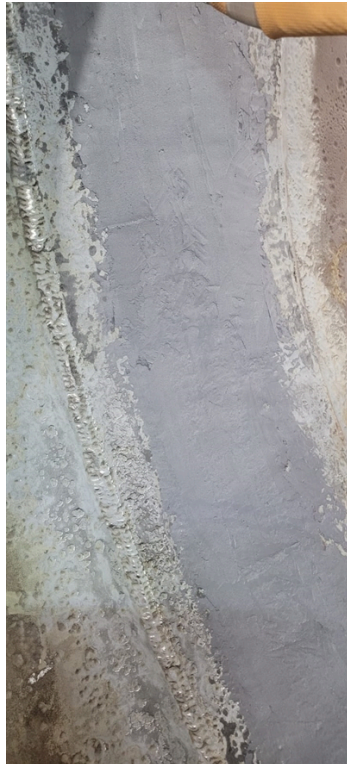
Deep pitting on the bow thruster tunnel due to cavitation

After surface preparation and rebuilding with Belzona 1311

Surface preparation was carried out using the MBX bristle blaster, degreased and allowed to dry. Pitting was filled with Belzona 1311 and two coats of Belzona 1321 was applied.

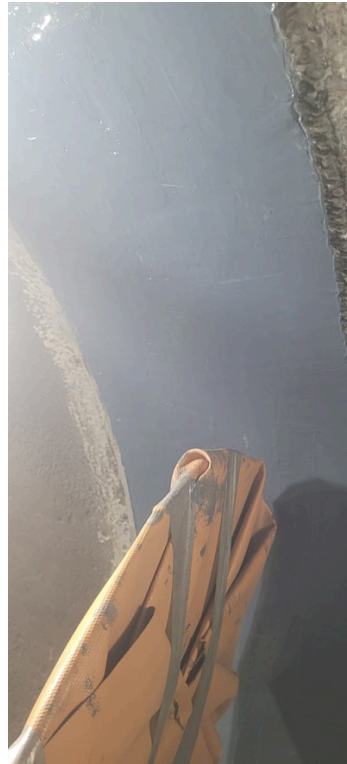
With first coat of Belzona 1321
