Belzona coating provides concrete protection & smooth surface for fish farm

ID: 9318

Industry: Food & Drink
 Application: TCC-Tanks and Chemical Containment Areas
 Substrate: Concrete
 Products: Belzona 5811DW (DW Immersion Grade)

Customer Location: United Kingdom
 Application Date: August 2023

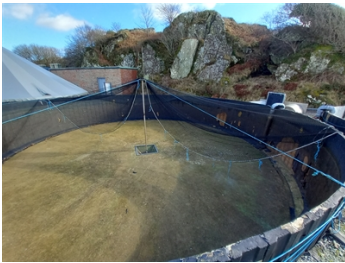
Concrete tanks had been installed & lined years previously with a Polyurea coating which had subsequently failed. This coating had disbonded in large areas & left the concrete open to degradation. The fish stored in the tank could suffer lacerations from the rough surface.

Failed coating

The existing coating was removed & concrete prepared mechanically. Any large gaps or joints were then filled before two coats of Belzona 5811DW2 was applied.

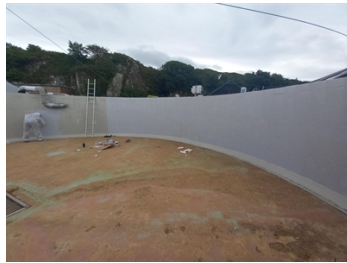
Belzona 5811DW2 application in progress

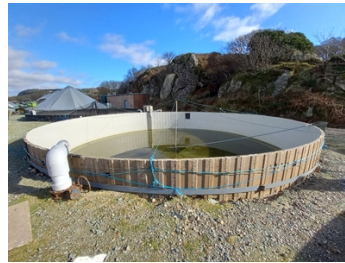
Completed application & filling in progress

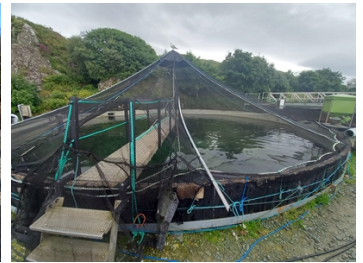
Application in service 12 months
