Belzona coating provides concrete protection & smooth surface for fish farm

ID: 9318

Industry: Food & Drink
 Application: TCC-Tanks and Chemical Containment Areas
 Substrate: Concrete
 Products: Belzona 5811DW (DW Immersion Grade)

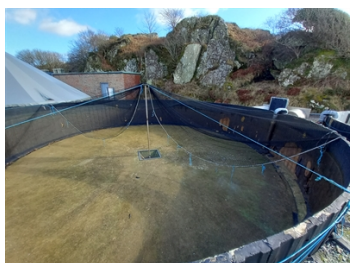
Concrete tanks had been installed & lined years previously with a Polyurea coating which had subsequently failed. This coating had disbonded in large areas & left the concrete open to degradation. The fish stored in the tank could suffer lacerations from the rough surface.

Failed coating

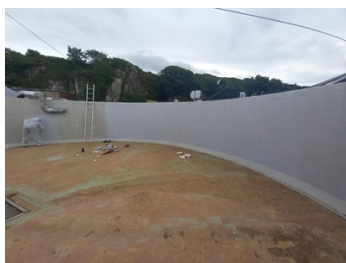
Belzona 5811DW2 application in progress

The existing coating was removed & concrete prepared mechanically. Any large gaps or joints were then filled before two coats of Belzona 5811DW2 was applied.

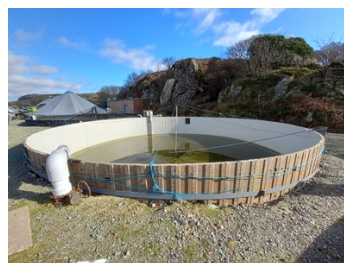
Completed application & filling in progress

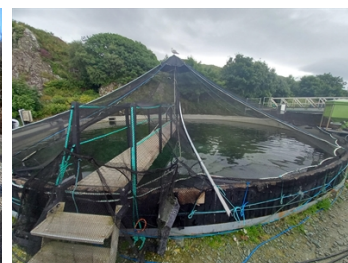
Application in service 12 months
