Belzona Repair Damage to Technical Trenches and Floors

Industry: Power
Application: FPA-Floor Problem Areas
Substrate: Concrete
Products: Belzona 4111 (Magma-Quartz), Belzona 4911 (Magma TX Conditioner)

Customer Location: Portugal
Application Date: September 2024

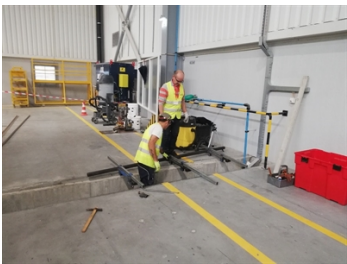
The problem is on the floor of a manufacturing warehouse. They have a problem on the floor of their blade factory, specifically in the joints of the technical trenches, which have metal covers along long lengths. These are found in many passage areas of the pavilion, being subject to impacts, scraping and support of loads from equipment and vehicles that circulate during production. With the movement of employees, equipment and vehicles, the metal rails at the joints are damaged, which can create dangerous situations for employees and damage to vehicles.

Application Situation

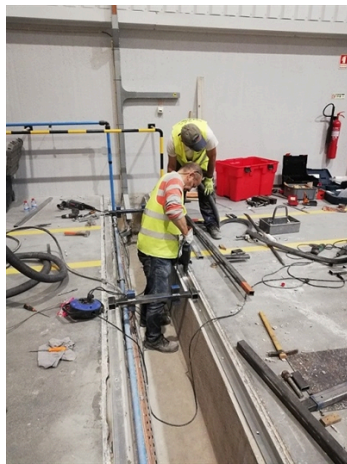
Surface preparation

The repair procedure consists of removing the metal covers, removing the support rails (profile "Z"), opening recesses in the concrete to receive the new "L" shaped support rails (metal angle), applying Belzona 4111 (Magma-Quartz) to the base of laying and fixing them, filling the open spaces in the concrete with Belzona 4111 (Magma-Quartz) always with prior application of 4911 (Magma TX Conditioner) on the base and on the metal gutter "L", finishing the surface with Belzona 4111(Magma-Quartz) to be at floor level.

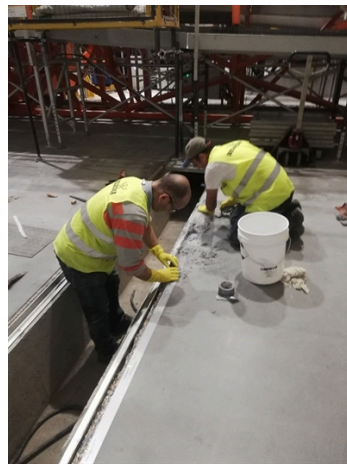
Applying Belzona 4111
(Magma-Quartz)

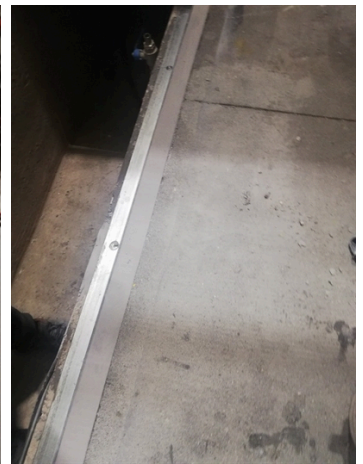
Finished application
