Belzona Repair Damage to Technical Trenches and Floors

ID: 9319

Industry:	Power	Customer Location:	Portugal
Application:	FPA-Floor Problem Areas	Application Date:	September 2024
Substrate:	Concrete		
Products:	Belzona 4111 (Magma-Quartz), Belzona 4911 (Magma TX Conditioner)

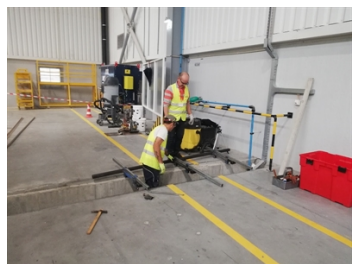
The problem is on the floor of a manufacturing warehouse. They have a problem on the floor of their blade factory, specifically in the joints of the technical trenches, which have metal covers along long lengths. These are found in many passage areas of the pavilion, being subject to impacts, scraping and support of loads from equipment and vehicles that circulate during production. With the movement of employees, equipment and vehicles, the metal rails at the joints are damaged, which can create dangerous situations for employees and damage to vehicles.

Application Situation

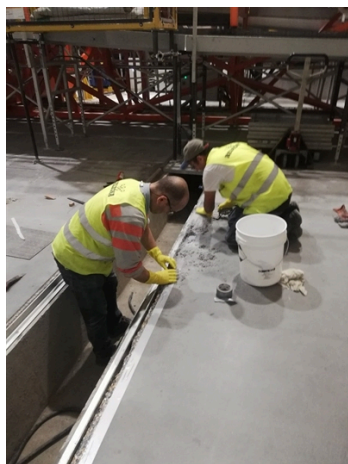
Applying Belzona 4111
(Magma-Quartz)

The repair procedure consists of removing the metal covers, removing the support rails (profile “Z”), opening recesses in the concrete to receive the new “L” shaped support rails (metal angle), applying Belzona 4111 (Magma-Quartz) to the base of laying and fixing them, filling the open spaces in the concrete with Belzona 4111 (Magma-Quartz) always with prior application of 4911 (Magma TX Conditioner) on the base and on the metal gutter “L”, finishing the surface with Belzona 4111(Magma-Quartz) to be at floor level.

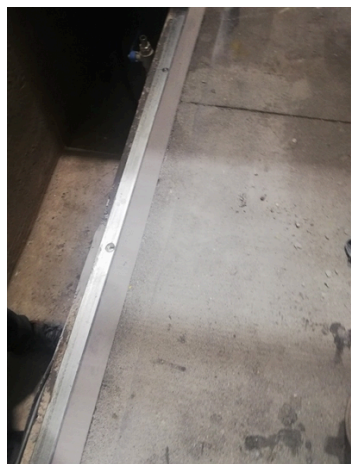
Finished application
