Belzona 3412 encapsulates Hub Connectors

ID: 9320

Industry: Oil & Gas
Application: GSS-Gaskets, Seals and Shims
Substrate: Carbon steel
Products: Belzona 3412, Belzona 8411

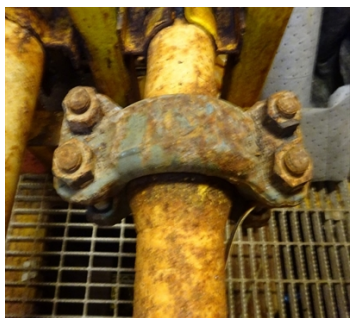
Hub connectors were experiencing corrosion in offshore environments. Within these connectors there are multiple voids where salt water can sit & cause corrosion.

Corroded hub connector

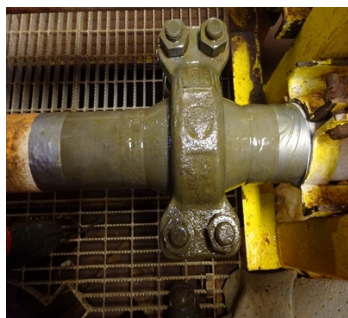
Surface preparation & Belzona 8411 applied

The connector was cleaned & coated with Belzona 8411. Bridging tape was then used to 'fair' and bridge large voids. Two coats of Belzona 3412 were then applied.

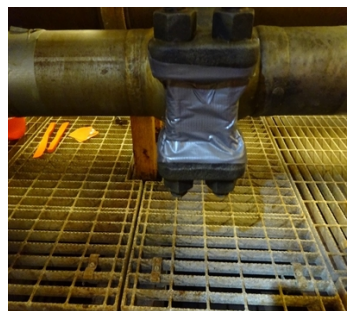
Bridging tape applied around voids

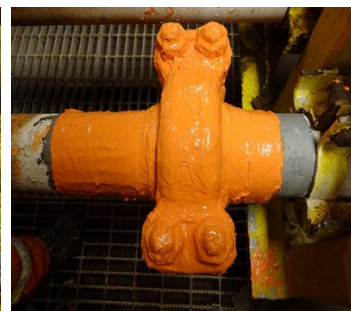
Two coats of Belzona 3412 applied
