# Belzona 3412 encapsulates Hub Connectors

ID: 9320

Industry: Oil & Gas  
Application: GSS-Gaskets, Seals and Shims  
Substrate: Carbon steel  
Products: Belzona 3412, Belzona 8411

Customer Location: Scotland  
Application Date: August 2020

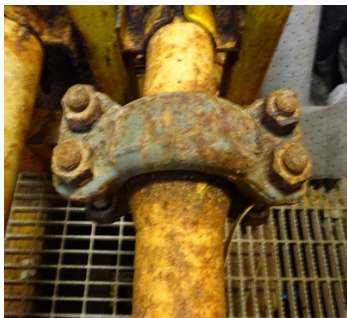
Hub connectors were experiencing corrosion in offshore environments. Within these connectors there are multiple voids where salt water can sit & cause corrosion.

Corroded hub connector
