Belzona SuperWrap 2 repairs chemical scrubber

Industry: Chemical & Petrochemical
Application: TCC-Tanks and Chemical Containment Areas
Substrate: Carbon steel
Products: Belzona 1111 (Super Metal), Belzona 1981 (SuperWrap II)

Customer Location: Scotland
Application Date: October 2018

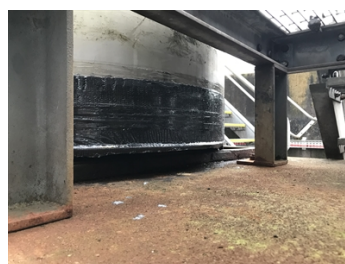
Close up

Chemical attack had caused through wall defects within a chemical scrubber. H2S reacting with water to form sulphuric acid was the main cause.

Through wall defects

The area was first prepared mechanically with an MBX Bristle Blaster. Belzona 1111 & small plates were then used to fair any corroded areas. Four wraps of Belzona SuperWrap II were then applied to reinforce the area.

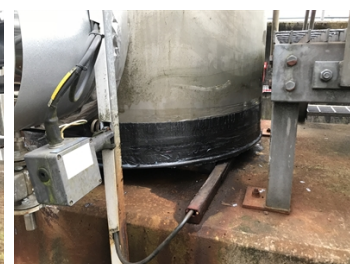
Completed application

As of October 2023 other than discolouration from UV Chalking this repair is still in excellent condition
