Belzona Saves Chiller Head

ID: 9323

Application: HEX-Heat Exchangers

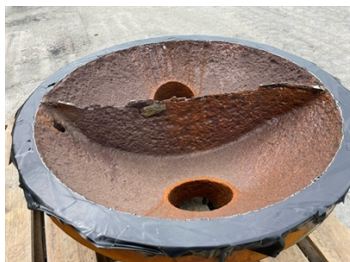
Chiller head was suffering from severe corrosion/chemical attack due poor water treatment.

Pre Job Inspection

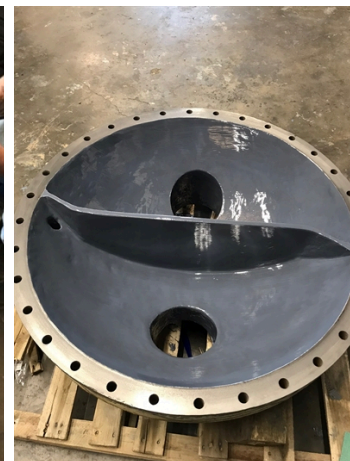
Complete Application with Belzona 1321

Equipment was repaired in 24-48 hrs. with no need for welding or hot work. Due to the fast turn around and repair cost of less than 25% of new, this application proved to be the best option for the client.
