Belzona Coating of New Chillers for Global HVAC Supplier

Application: HEX-Heat Exchangers

Products: Belzona 1321 (Ceramic S-Metal), Belzona 1341 (Supermetalgilde)

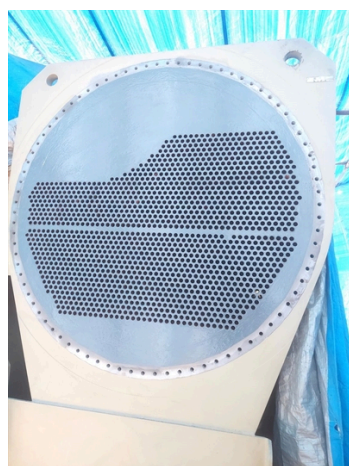
The same problem happened to our client. Two new chillers have been shipped to them but arrived severely corroded which delayed the launching of the whole living complex.

Corroded chiller.

Chiller after Belzona 1321 and Belzona 1341 applications.

Application was completed as per the Belzona product's respective Instructions for Use.

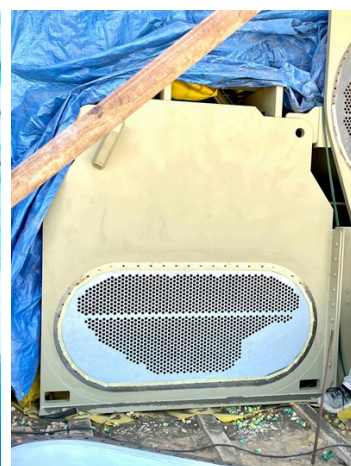
Corroded chiller.

Chiller after Belzona 1321 and Belzona 1341 applications.
