# Belzona SuperWrap II repairs and strengthens ash chutes

Industry: *Other*  
Application: *SHM-Solids Handling Machinery*

Customer Location: *Bristol*  
Application Date: *March 2024*

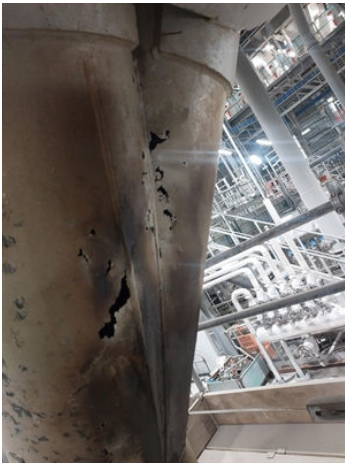
*The customer burns non-recyclables and re-use the energy from the combustion. The ash left from burning comes down the chutes wearing holes due to sliding abrasion specifically on the elbows and joints where the ash has more contact.*

Ash chute had worn due to sliding abrasion

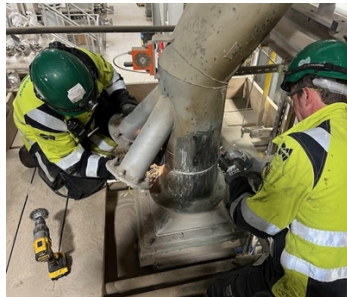
Damaged area was bristle blasted to key profile

The substrate was bristle blasted to provide the required substrate key profile. The termination points were taped out and Belzona 1983 SuperWrap II was applied 50/50 to increase strength to specified standard. A consolidator sheet was applied until application had cured to IFU specification.

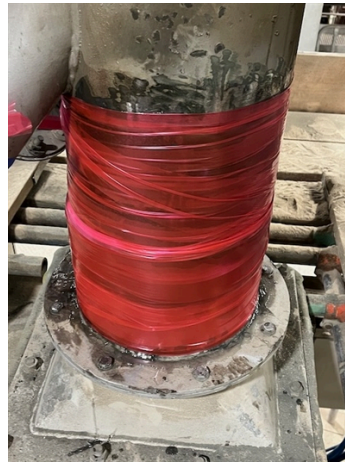
Belzona 1983 SuperWrap II is applied then Belzona 9382 release film is applied to consolidate application

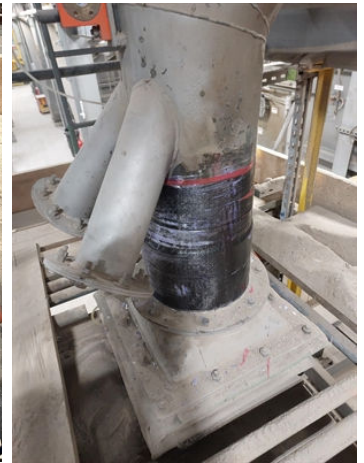
Release film is removed and repair application is complete
