# Belzona SuperWrap II repairs and strengthens ash chutes

ID: 9325

Customer Location: Bristol  
Application Date: March 2024

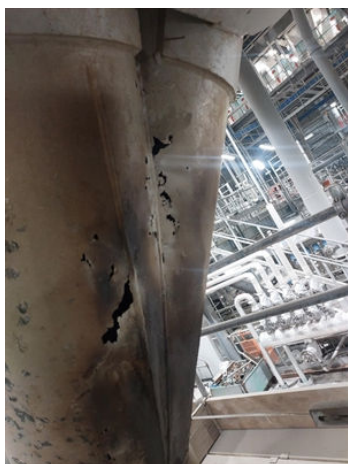
The customer burns non-recyclables and re-use the energy from the combustion. The ash left from burning comes down the chutes wearing holes due to sliding abrasion specifically on the elbows and joints where the ash has more contact.

Ash chute had worn due to sliding abrasion

All the chutes are very thin and near impossible to weld where holes had appeared so the customer liked the idea of 1983 SuperWrap II which would repair and seal the holes. It would also provide strength to the thin through wall and give some wall strength to the worn away sections.

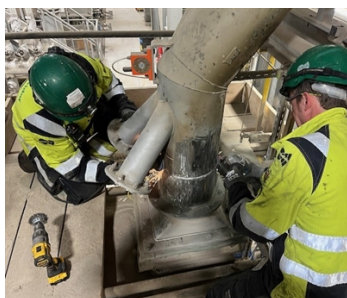
Damaged area was bristle blasted to key profile

The substrate was bristle blasted to provide the required substrate key profile. The termination points were taped out and Belzona 1983 SuperWrap II was applied 50/50 to increase strength to specified standard. A consolidator sheet was applied until application had cured to IFU specification.

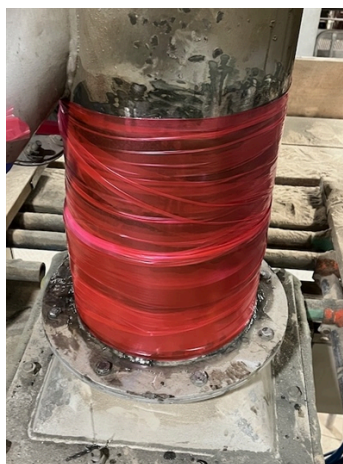
Belzona 1983 SuperWrap II is applied then Belzona 9382 release film is applied to consolidate application

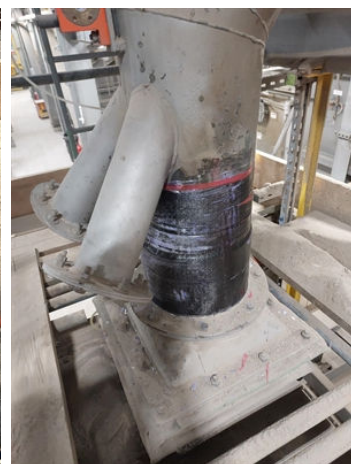
Release film is removed and repair application is complete
