# BELZONA SUPERWRAP II APPLICATION ON MONEL 400 BELLOWS BETWEEN CONVOLUTIONS

Industry: Chemical & Petrochemical  
Application: TCC-Tanks and Chemical Containment Areas

Customer Location: Runcorn  
Application Date: March 2024

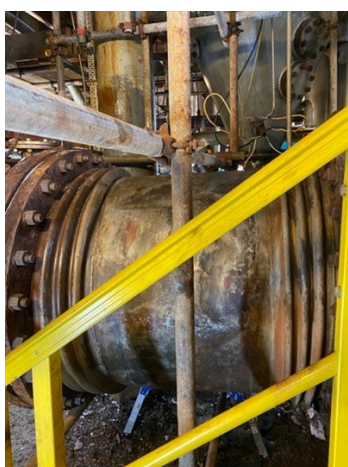
There was a small crack in the Monel which needed terminating and filling with Belzona 1511. The bellow also required strengthening.

Worn and cracked bellows between two convolutions

Surface preparation was done using manual tools removing rust and debris from the surface taking care not to penetrate the 2mm thick Monel Bellow. The crack was terminated and filled with Belzona 1511.

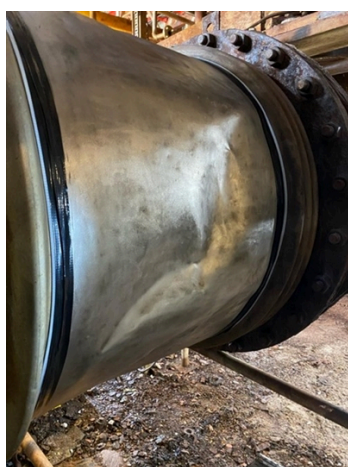
Crack in the bellows terminated and filled with Belzona 1511

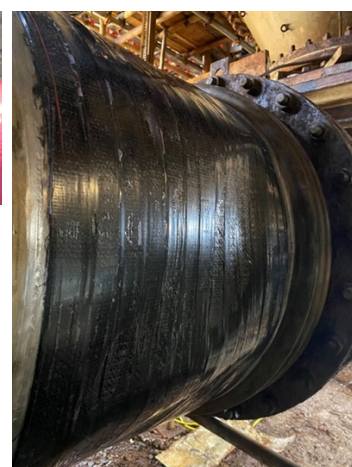
Completed temporary solution for cracked and worn bellow

Due to site imposed limitations, the repair was carried out as a temporary solution.

Belzona 1983 was then applied to increase strength and durability of the bellow.
