# Protection of stainless-steel scrubber vessel from chemical attack

ID: 9328

Application: TCC-Tanks and Chemical Containment Areas

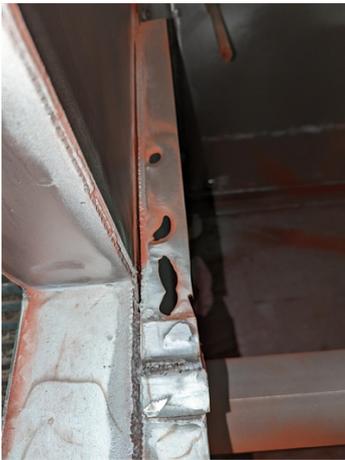
Newly fabricated stainless-steel scrubber vessels were put in service without a coating thinking the stainless-steel will provide enough protection. After 3 months they were having through wall defects in several parts of the vessel.

Vessel initially after chemical attack.

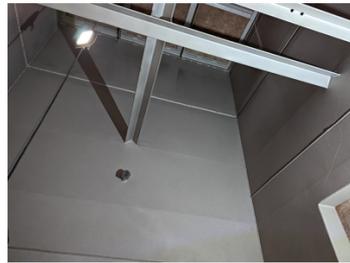
After grit blasting.

The whole vessel was grit blasted. They had welds and irregular surfaces which were smoothed and filled with Belzona 1111. Then Belzona 1111 was frost blasted and two coats of Belzona 4311 were applied.

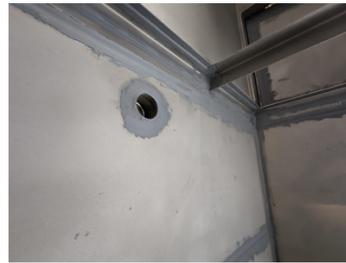
Weld seams and gaps covered with Belzona 1111.

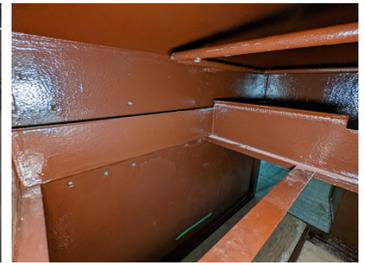
After application of two coats of Belzona 4311.

We were able to secure the job as we created coated samples for the customer and sent them for immersion testing. The product performed well so they decided to proceed with the application. The vessel was opened after 3 months and then after 1 year and the coating was still in good shape protecting the vessel.
