Protection of stainless-steel scrubber vessel from chemical attack

ID: 9328

Application: TCC-Tanks and Chemical Containment Areas

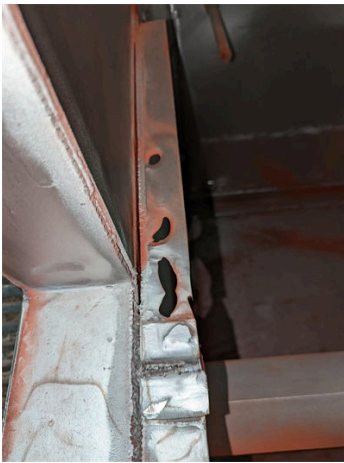
Newly fabricated stainless-steel scrubber vessels were put in service without a coating thinking the stainless-steel will provide enough protection. After 3 months they were having through wall defects in several parts of the vessel.

Vessel initially after chemical attack.

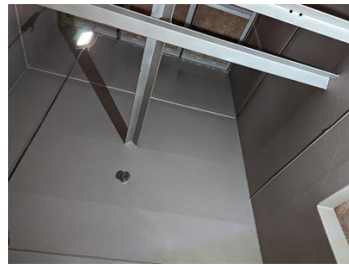
After grit blasting.

The whole vessel was grit blasted. They had welds and irregular surfaces which were smoothed and filled with Belzona 1111. Then Belzona 1111 was frost blasted and two coats of Belzona 4311 were applied.

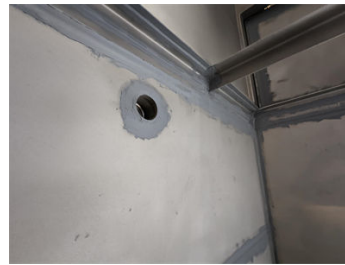
Weld seams and gaps covered with Belzona 1111.

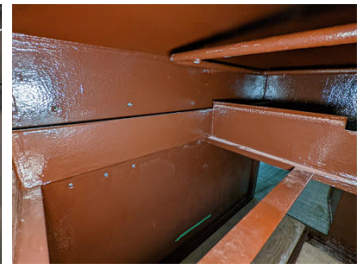
After application of two coats of Belzona 4311.

We were able to secure the job as we created coated samples for the customer and sent them for immersion testing. The product performed well so they decided to proceed with the application. The vessel was opened after 3 months and then after 1 year and the coating was still in good shape protecting the vessel.
