Main Station Transformer flange sealed with Belzona 3412

ID: 9329

Industry: Power
Application: GSS-Gaskets, Seals and Shims
Substrate: Carbon steel
Products: Belzona 3412, Belzona 8411

Customer Location: Ireland
Application Date: March 2023

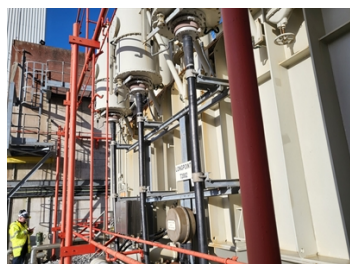
Main Station transformer
