Pipe Strengthening with Belzona SuperWrap II

ID: 9330

Application: VPF-Valves, Pipes and Fittings

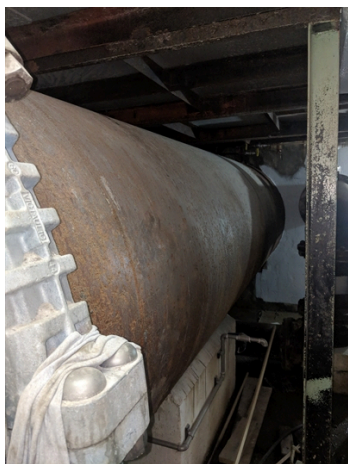
A 60" carbon steel pipe that had suffered from external corrosion and metal loss over the years. The defective area was about 15 feet. They required a solution that would reinstate the structural integrity of the pipe.

Corroded section of the pipe

We used ASME PCC2 equations to estimate the number of wraps required to retrofit the pipe to design conditions. The defect was type A (thin wall), corrosion was external, and the pressure was relatively low (25 psi). 2 wraps of Belzona SWII were recommended to structurally reinforce the pipe and effectively stop corrosion on the pipe. This repair system can remain maintenance-free for up to 20 years.

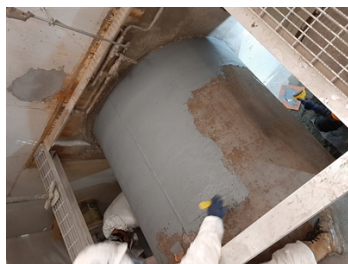
Application of Belzona 1121

First, the pipe was grit blasted and prepared according to SSPC SP10. All the pitting and resurfacing was then done with Belzona 1121(Super XL-Metal) because of its longer overcoating time. The next day, they started applying Belzona SWII. They applied the wrap in 4 foot sections at a time, so every 4 feet they would consolidate the repair with Belzona 9382 and continue with the next section. Though the application was during colder climate, Belzona 1982 was chosen to give more working life and allow the crew to complete the application properly.

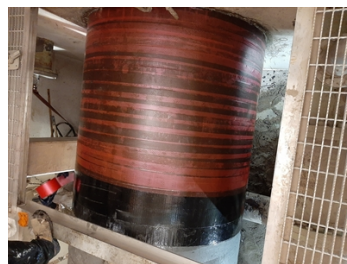
Wrapping in 4 foot sections

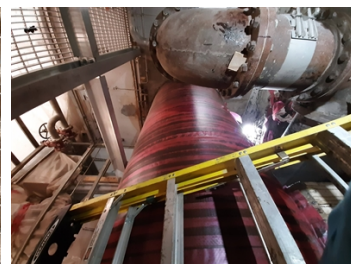
Wrap completed and consolidated with Belzona 9382
