Protection of Wastewater Centrifuge

ID: 9331

Customer Location: Pickering, Ontario

Application: CEP-Centrifugal Pumps

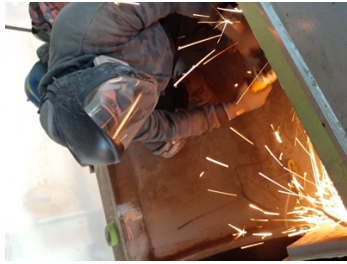
During surface preparation

The steel substrate was prepared to and in accordance with SSPC-SP 11, Bare Metal Power Tool Cleaning. This method of surface preparation was chosen as the plant was in operation and abrasive blasting was not an option. Once the substrate was prepared, Belzona 1111 was applied as a stripe coat to smooth out any defects, joints and seams. Belzona 1341 was then applied in two coats of alternate colors

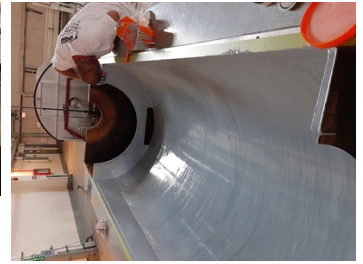
Finished application
