Belzona Trials New SF6 Leak Solution

ID: 9332

Industry: Power
Application: GSS-Gaskets, Seals and Shims
Substrate: Aluminum
Products: Belzona 1981 (SuperWrap II), Belzona 7311

Customer Location: Lackenby, Cleveland
Application Date: November 2023

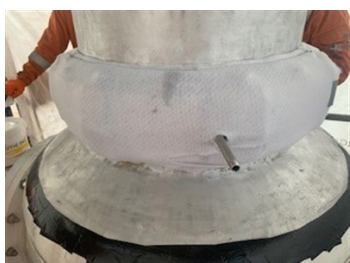
SF6 flange following surface preparation to SSPC-SP11, installation of the Backing Rod, tape, Redirection Nozzle & Breather Membrane.

The substrate (Aluminium) was first prepared in accordance with SSPC-SP11 Surface Preparation using an MBX (using a Stainless Steel wheel to prevent bi-metallic contamination). Once prepared, a backing-rod was applied behind the flange bolts and tape was applied over the bolts themselves (this prevents Belzona from adhering to them and allows a smoother surface transition). A Breather Membrane was applied around the circumference of the flange encapsulating it in its entirety, a Redirection Nozzle was also fitted to channel the leaking gas. Belzona 7311 was then applied to seal the membrane prior to the application of the impregnated Belzona 9341 (Reinforcement Sheet). The newly applied Belzona 7311 was then wetted out using Belzona 1981 (Winter Grade) SWII Resin prior to the application of 5 x wraps of Belzona 9371 (SWI Reinforcement Sheet) forming 10-layers (due to the 50% overlap). This was then left to polymerise (generating a slight self-curing exotherm) prior to a final encapsulating layer of Belzona 7311. The application required approximately 6L of Belzona 7311 & 5L of Belzona 1981. The application was carried out in accordance with a modified version of Belzona System Leaflet VPF-12.
