Belzona Trials New SF6 Leak Solution

ID: 9332

Industry: Power
Application: GSS-Gaskets, Seals and Shims
Substrate: Aluminum
Products: Belzona 1981 (SuperWrap II), Belzona 7311

Customer Location: Lackenby, Cleveland
Application Date: November 2023

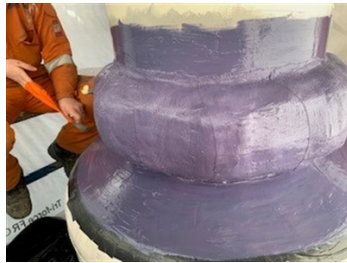
Wetting out of the Breather Membrane and vertical application of Reinforcement Sheets (Belzona 9341) using Belzona 7311.

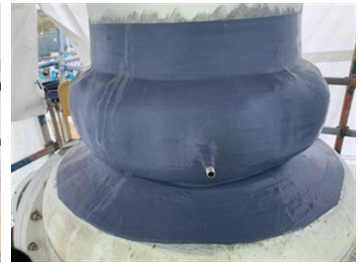
Final application after a further encapsulating layer of Belzona 7311.

Belzona conducted this application on a trial basis and had to reduce the leak by a minimum of 80%. The application was undertaken within a 12-hour shift.

The solution was classed as successful after 3-months of service and is now being rolled out at other national substations across the UK
