# PETROCHEMICAL FLANGE ENCAPSULATION

ID: 9333

**Industry:** Chemical & Petrochemical  
**Application:** VPF-Valves, Pipes and Fittings  
**Substrate:** Carbon steel  
**Products:** Belzona 3412, Belzona 8411

**Customer Location:** Ontario Sarnia  
**Application Date:** October 2017

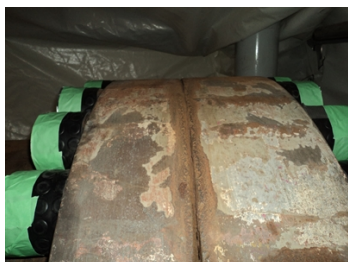
Preparation performed using hand tooling completed.

Before application of the product, the surface of the flanges was prepared and cleaned with power tools and cleaner degreaser. To seal the gap between the flange faces, a strip of bridging tape was used. Belzona 8411 was then applied to the entire application surface. After, rubber caps were installed over the bolts and nuts.

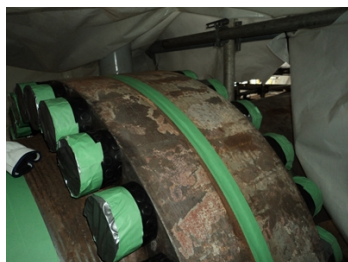
Flanges ready for Belzona 8411 release agent inhibitor.

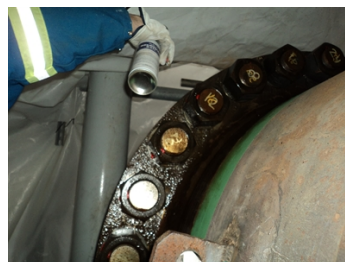
Application of Belzona 8411.

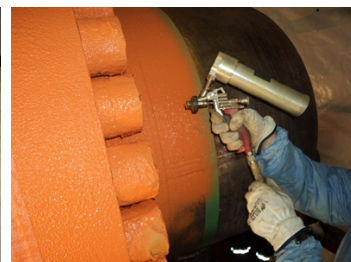
Application of Belzona 3412 encapsulating membrane.
