Glass coated pipe in very acidic service at 250 F temperature in need of repair.

ID: 9334

Industry: Chemical & Petrochemical
Application: VPF-Valves, Pipes and Fittings
Substrate: Carbon steel
Products: Belzona 1511 (Super HT-Metal), Belzona 1593

Customer Location: Saint Gabriel, LA
Application Date: April 2024

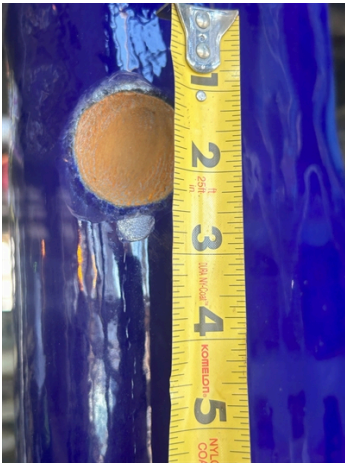
This was the most damaged area on the glass coated pipe. 1 1/2" x 1 1/2" x 1/2"

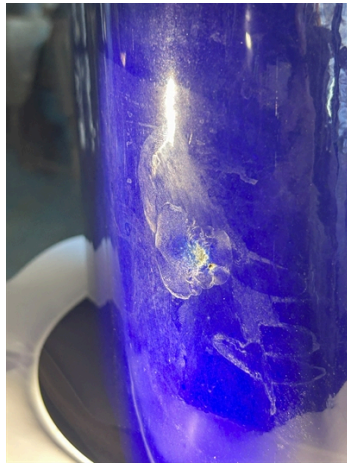
Smaller damaged area of glass coated pipe.
