Solvents Pump Repair Belzona 1321 and Belzona 1121

ID: 9335

Application: CEP-Centrifugal Pumps

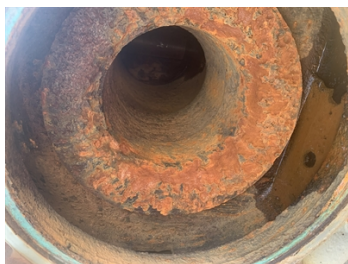
Close up of pitting BEFORE

Made repairs at the inlet and filled in any pitting using Belzona 1121

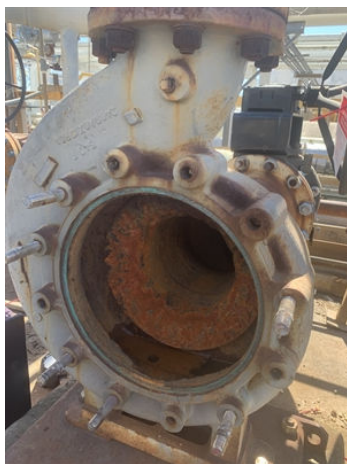
Drainage issues inside facility was causing backups. While dredging canals client took opportunity to improve pump for efficiency.

Pump in place prior to improvements
