Pipe in a wastewater pumping station reinforced with Belzona SWII

ID: 9337

Application: VPF-Valves, Pipes and Fittings

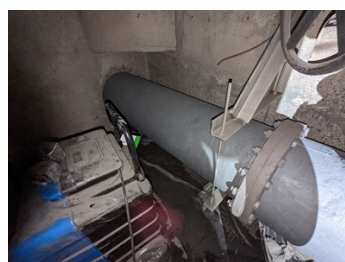
Resurfaced with Belzona 1121

The substrate was grit blasted to near white metal. Since there was a lot of moisture and high humidity, the contractor had to install a dehumidifier to control the environment. The pitting and irregular surfaces were rebuilt and smoothed with Belzona 1121. Then 2 wraps of Belzona SWII were applied to strengthen the weakened pipe. The resin selected for this application was Belzona 1982. Two coats of Belzona 5811 were applied to protect the flanges.

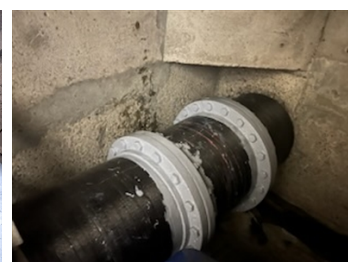
Application completed with SWII reinforcement and coated flanges

The selling point of the application was the engineering design we provided following ASME PCC2 standard for 20 years of protection. The application was carried out without disrupting the service of the pump station which was ideal for the customer as they could not afford to shutdown. The pipe was inspected after 1 year, the wrap and the coating were still in perfect condition.
